New Hampshire Volunteer Lake Assessment Program

2002 Bi-Annual Report for Perkins Pond Sunapee

NHDES
Water Division
Watershed Management Bureau
6 Hazen Drive
Concord, NH 03301

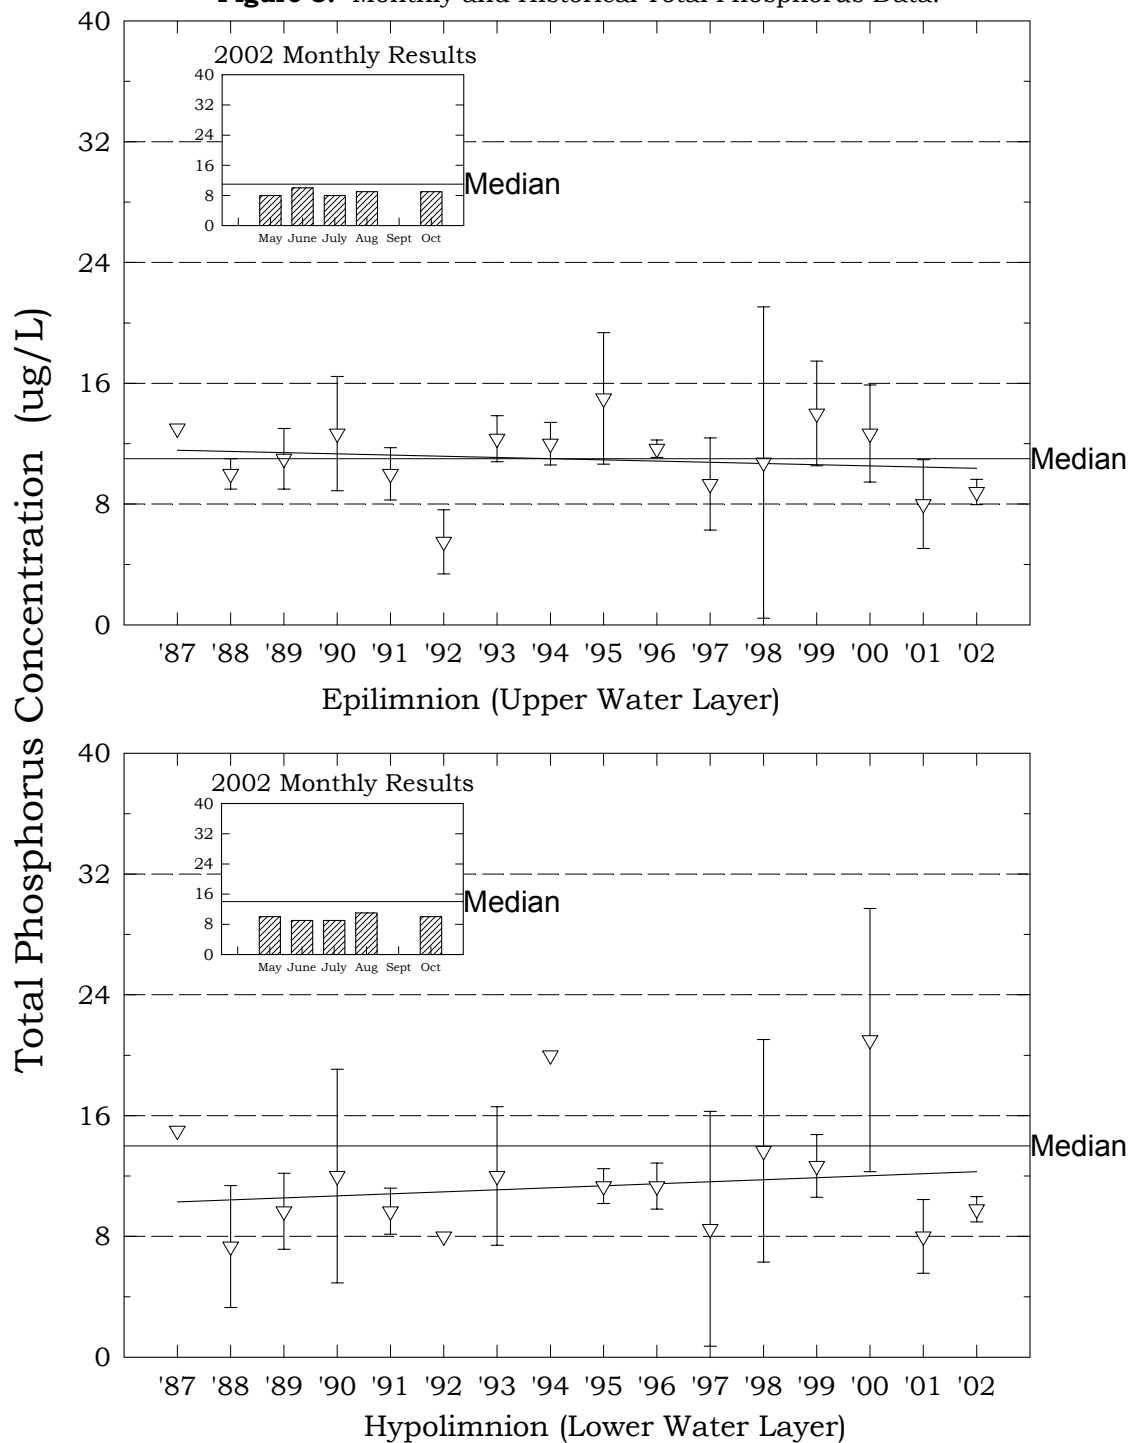
Figure 3. Monthly and Historical Total Phosphorus Data.

- **Figure 3 and Table 8:** The graphs in Figure 3 (Appendix A) show the amounts of phosphorus in the epilimnion (the upper layer) and the hypolimnion (the lower layer); the inset graphs show current year data. Table 8 (Appendix B) lists the annual maximum, minimum, and median concentration for each deep spot layer and each tributary since the pond has joined the program.

The current year data for the epilimnion (the top inset graph) and the hypolimnion (bottom inset graph) show that the total phosphorus concentration remained **relatively stable** this season.

The historical data for the epilimnion (upper layer) and the hypolimnion (lower layer) show that the 2002 total phosphorus mean is **less than** the state median.

Overall, the statistical analysis of the historical data show that the total phosphorus concentration in the epilimnion (upper layer) and the hypolimnion (lower layer) has **not significantly changed** (either *increased* or *decreased*) since monitoring began in **1987**. Specifically,

the total phosphorus concentration in the epilimnion and hypolimnion has **varied (meaning fluctuated)**, but has not *continually increased or decreased* since monitoring began. (Note: Please refer to Appendix E for the statistical analysis explanation and data print out.)

One of the most important approaches to reducing phosphorus loading to a waterbody is to continually educate watershed residents about its sources and how excessive amounts can adversely impact the ecology and value of lakes and ponds. Phosphorus sources within a lake or pond's watershed typically include septic systems, animal waste, lawn fertilizer, road and construction erosion, and natural wetlands. If you would like to educate watershed residents about how they can help to reduce phosphorus loading into the pond, please contact the VLAP Coordinator.
